Manhole Inspection Summary

Manhole # S04II2017MH

Insp Date: **7/14/06 10:19 AM**

Location Address: **3402 HATTON RD**

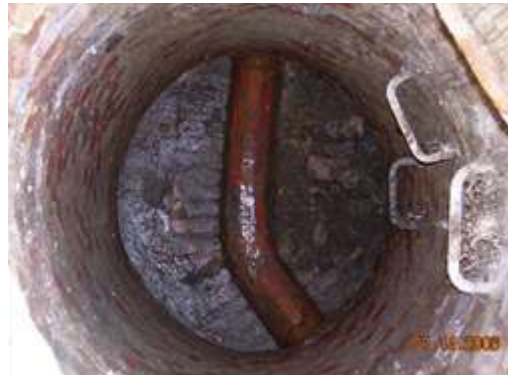
Top View

Condition: ☐ Sound ☐ Cracked ☐ Root Intrusion ☒ **Loose Brick** ☒ **Deteriorated**

Infiltration: ☐ None ☒ **Joint** ☐ Cracks ☒ **Mortar** ☐ Roots ☐ Wall

Surcharge ☒ **Evidence Of Surcharge** Depth: **2** (ft.) ☐ Active Surcharge Present

Adjustment, Corbel and Barrel infiltration.
Evidence of surcharge - Bench debris.

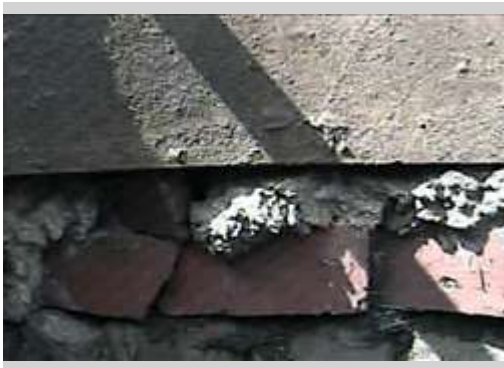
Defect

Frame Offset: **0** (in.) Condition: ☐ Sound ☐ Cracked ☒ **Leaks**

Frame leaks. Adjustment deterioration,
loose brick and infiltration.

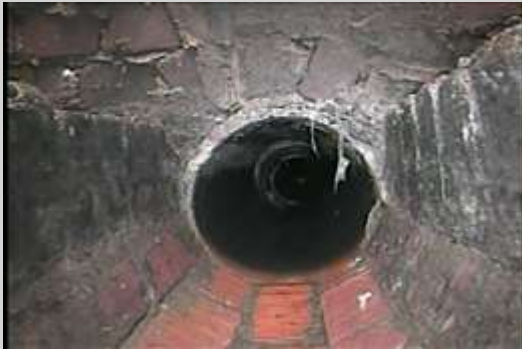
8 in. Circular Gravity Sewer Pipe Out @ 12 O'Clock

Infiltration: **Evidence** Pipe Seal Cond: **Roots**

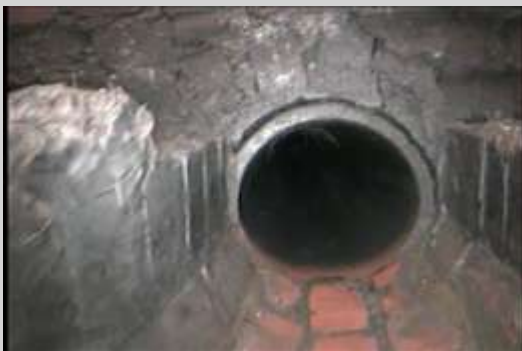
8 in. Circular Gravity Sewer Pipe In @ 5 O'Clock

Barrel deterioration and infiltration.

Infiltration: **Evidence** Pipe Seal Cond: **Unknown**
